POPPLETON HISTORIC STUDY

300-326 N. Carey Street

B-2411 300-326 N. Carey Street Block 153 Lots 001-014 Baltimore City

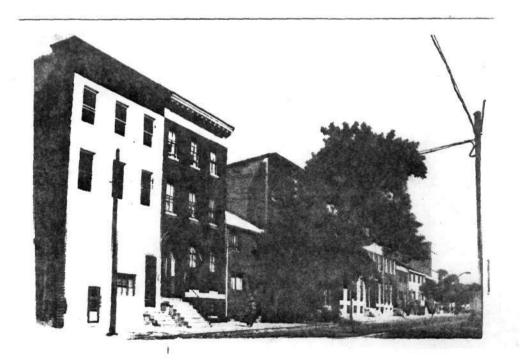
The old houses match in date and kind the houses on the west side of Carey Street in the block south. They are great nouses, huge scale, and what remains of them should stay. Numbers 300 and 302 have been badly remodelled and 312 is formstoned.

The two-story new houses are ugly but useful. They conflict with the old houses, have no grace and even of their kind are poor examples.

Moderate 2-way street; needs large street trees to keep company with the one remaining Linden which should be fed and protected. The new expressway is abuilding at the north end of this block.
